EICCT TECHNOLOGY

FINAL COAT MODULE

TEST SUMMARY

U.L.C. (UNDERWRITERS' LABORATORIES OF CANADA) TEST RESULT PHOTOS

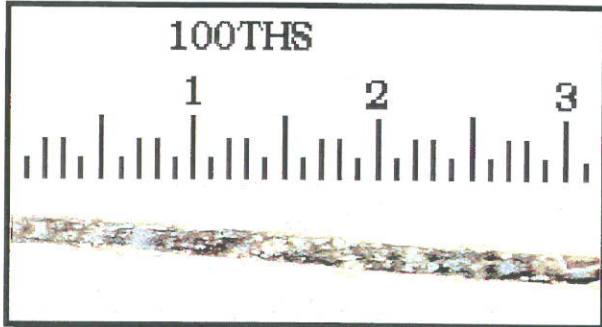
FINAL COAT® CORROSION MODULE PROTECTED PANEL

The following was noted: Scribe marks on all the panels showed no corrosion or rust.

GALVANIZED BODY PANEL SCRATCHED TO BARE METAL WHEN **PROTECTED** BY THE FINAL COAT CM-2000 MODULE (1000 HRS SALT SPRAY EXPOSURE)

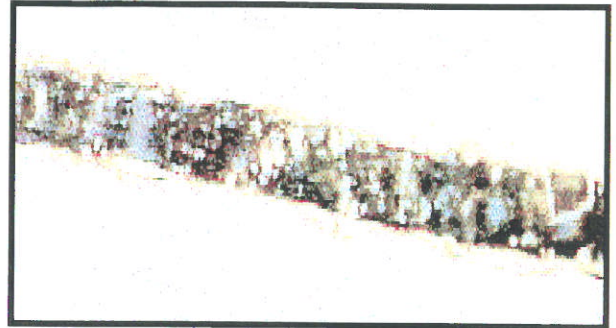
CLOSE UP (25X) OF AREA **PROTECTED** BY THE FINAL COAT MODULE (1000 HRS SALT SPRAY EXPOSURE)

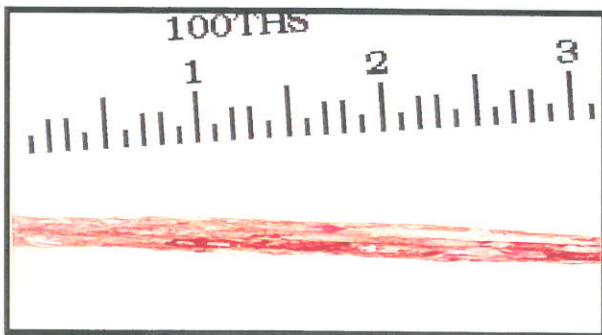
UNPROTECTED PANEL

The test panel was examined for corrosion, rust or pitting at the scribe mark after exposure to a 5% salt solution for one thousand (1000) hours using an Olympus optical microscope. The following was noted: the scribe mark showed rust along its entire length. There was a noticeable difference in the appearance of the scribe mark on this sample as compared to the scribe marks on the samples in Test # 1.

GALVANIZED BODY PANEL SCRATCHED TO BARE METAL WITHOUT MODULE PROTECTION (1000 HRS SALT SPRAY EXPOSURE)

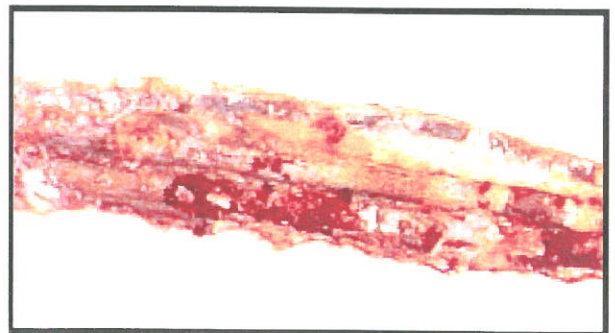
CLOSE UP (25X) OF **UNPROTECTED** AREA SHOWING PITTING, METAL LOSS AND SEVERE CORROSION (1000 HRS SALT SPRAY EXPOSURE)
